#### **5.3.4 CHARACTERISTICS OF THIS PROPOSAL**

EAST LINK BRIDGE

Client	Royceaton Ltd.	Date	17/10/03
Project	South Link Bridge	Scale	Not to scale
Drawing No.	Figure 5.3.1	Source	
Description	Ecological Habitat Map	Prepared By	SR
		Revision No.	1

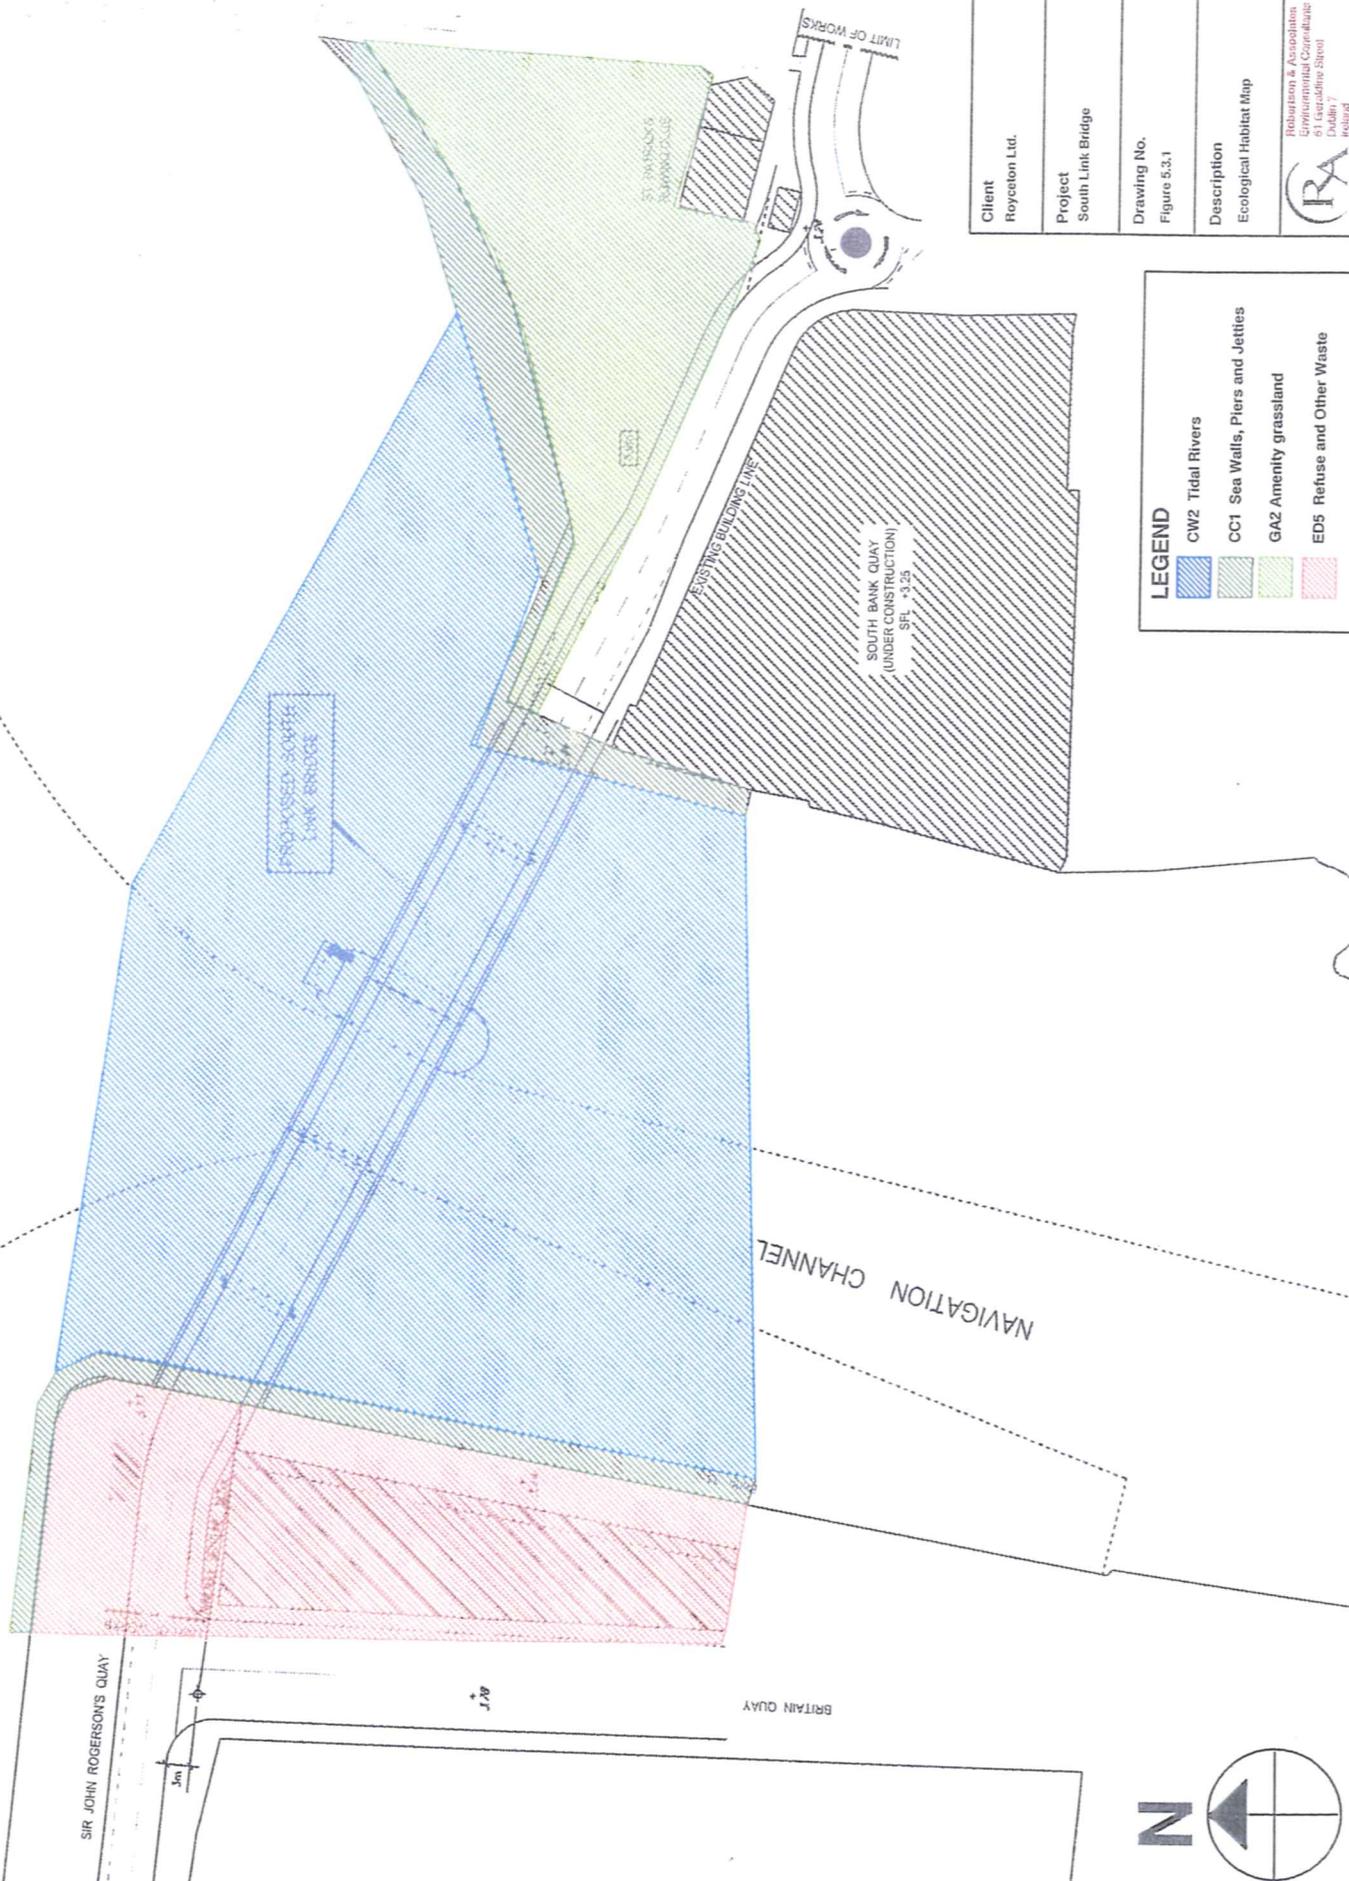
- CW2 Tidal Rivers
- CC1 Sea Walls, Piers and Jetties
- GA2 Amenity grassland
- ED5 Refuse and Other Waste

5.3.57 As can be seen in Figure 5.3.1, this habitat bounds the tidal river. It is comprised of a built granite sea wall to the east and west of the proposed crossing and rock boulders adjacent to the amenity grassland habitat. This habitat contains an extremely high degree of litter.

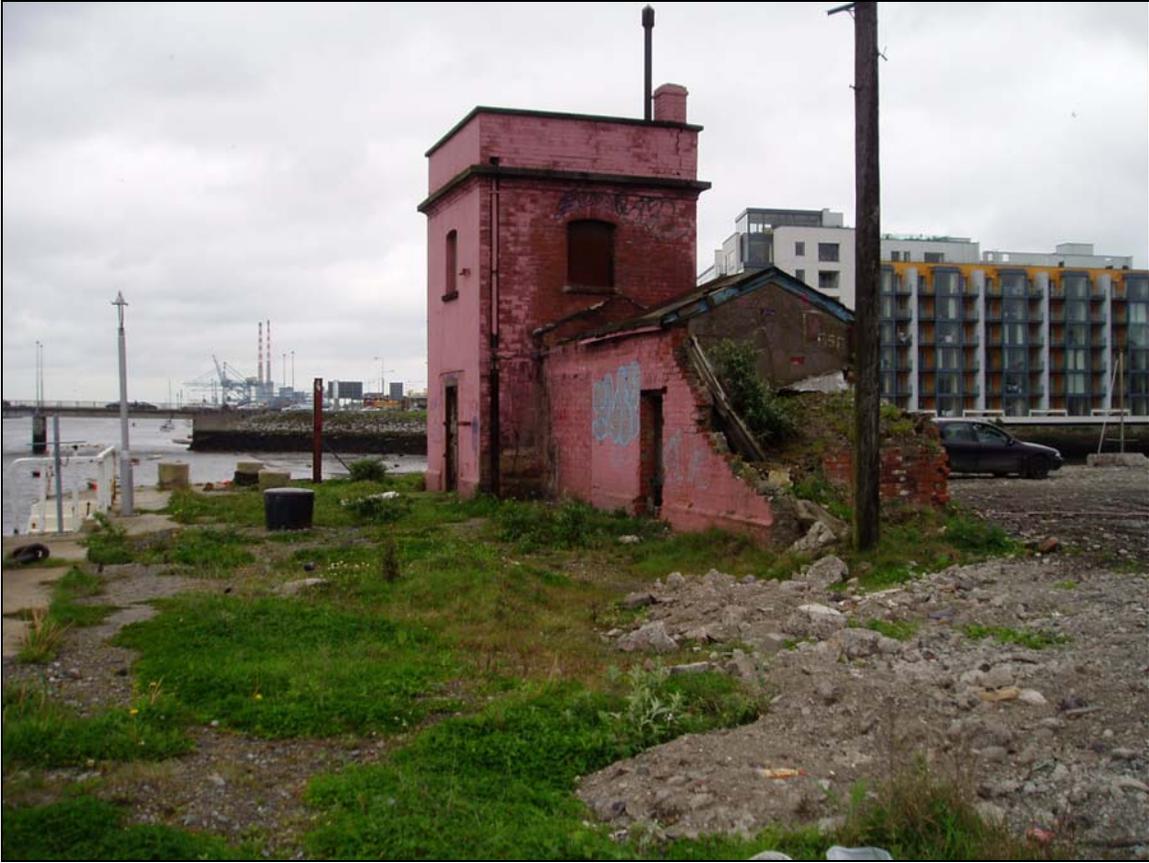
**Plate 8.1: The Hailing Station (a protected structure), at the corner of Sir John Rogerson's Quay and Britain Quay.**

Two-storey, single-bay, flat-roofed tower with single-storey, two-bay extension on the west side. The walls are of brick construction and have been painted red. There is a door at ground floor level on the north side with a window in each of the elevations on the upper floor. There is a single chimney on the south side. The single-storey extension has a pitched roof. There is a door and a blocked-up opening in the north elevation of the extension. On the west side of the north elevation of the extension, the brick wall has been partially demolished and tapers down to ground level.
